**LEAD-BASED PAINT  
RISK ASSESSMENT REPORT**

2190 NW 8th Street  
Ocala, FL 34475

**PERFORMED ON:**  
July 22, 2023

Re: Lead-Based Paint Inspection/Risk Assessment Report

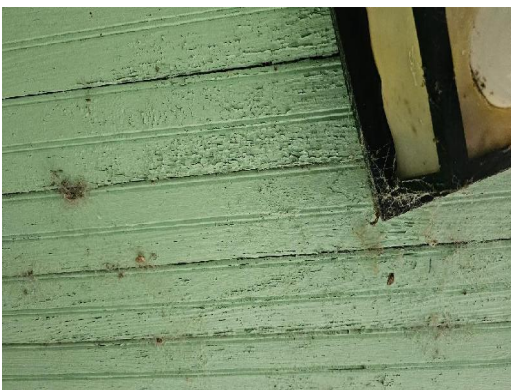
Read No.	Wall	Structure	Location	Member	Paint Cond	Substrate	Paint Color	Lead (mg/cm <sup>2</sup> )	Mode
008 Exterior									
067	B	Porch Ceilin	Rgt		D	Wood	green	5.2	QM

Exterior(008) B-Wall, Right  
Wood Porch Ceiling  
Lead-Positive, Deteriorated

- Option A. Paint film stabilization of all lead positive components by application of 1 coat of Kilz primer or equivalent over a LSWP prepared surface and 2 top coats of exterior exposure residential paint following manufacturer's recommendations. Color chosen by owner. (IC)
- Option B. Enclosure of all lead-positive components with vinyl soffit/metal coil stock using LSWP.
- Option C. Encapsulation of lead-positive components by application of LBC (Lead Barrier Compound) over a LSWP prepared surface.
- Option D. Removal of lead-positive components and replacement with material similar in appearance, composition and finish using LSWP.
- Option E. Remove lead-based paint chemically and repaint using LSWP.

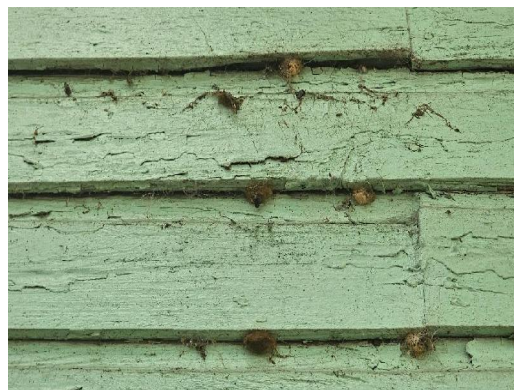
Exterior(008) B-Wall, Right  
Wood Wall  
Lead-Positive, Deteriorated

- Option A. Paint film stabilization of siding by application of 1 coat of Kilz primer or equivalent over a LSWP prepared surface and 2 top coats of exterior exposure residential paint following manufacturer's recommendations. Color chosen by owner. (IC)
- Option B. Enclosure of walls with house wrap and vinyl siding using LSWP.
- Option C. Remove lead-based paint chemically and repaint using LSWP.

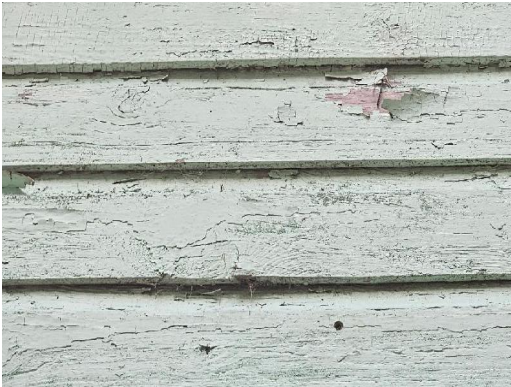
Exterior(008) D-Wall, Center  
Wood Wall  
Lead-Positive, Deteriorated
