ASBESTOS SURVEY REPORT

717 NW 13th Avenue
Ocala, FL 34475

December 27, 2023

**RE: Limited Asbestos Survey
Single-Family Detached Dwelling
717 NW 13th Avenue
Ocala, FL 34475**

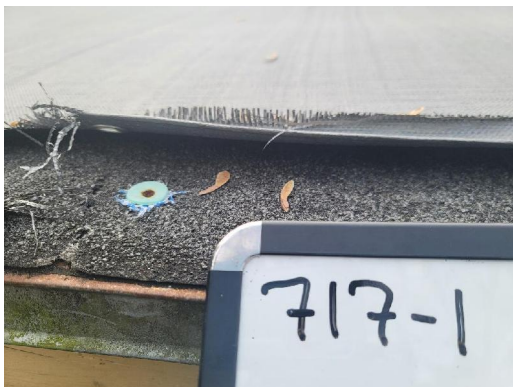
717-1
Rolled Asphalt Roofing/Tar
Typical Exterior Roof

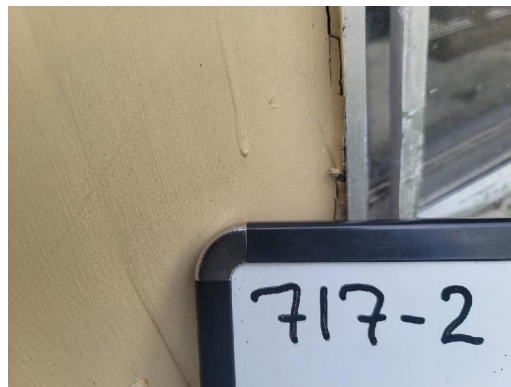
717-2
Caulk
Typical Exterior Windows

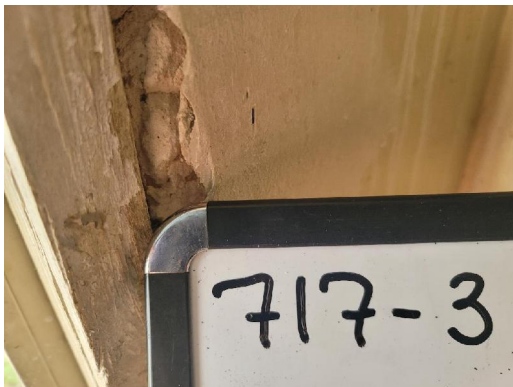
717-3
Drywall/Joint Compound
Typical Interior Walls/Ceilings

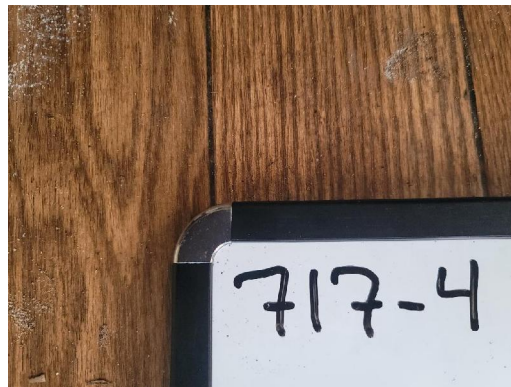
717-4
Rolled Flooring
Interior Kitchen/Top Layer

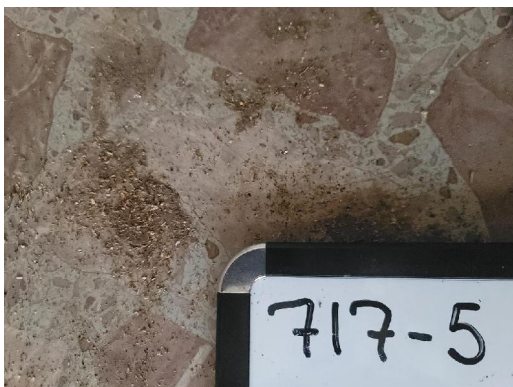
717-5
12"x12" Floor Tile/Adhesive
Interior Kitchen/Bottom Layer

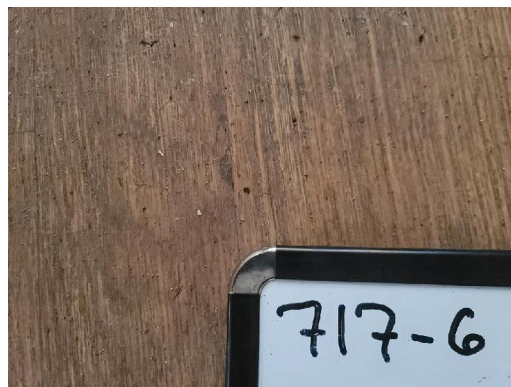
717-6
Rolled Flooring/Adhesive
Interior Dining Room

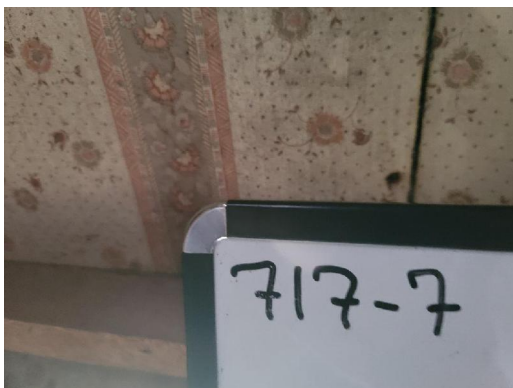
717-7
Wallpaper
Interior Southeast Bedroom Ceiling

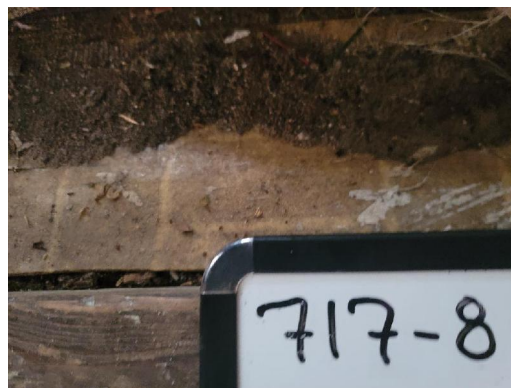
717-8
Rolled Flooring/Adhesive
Interior Southeast Bedroom

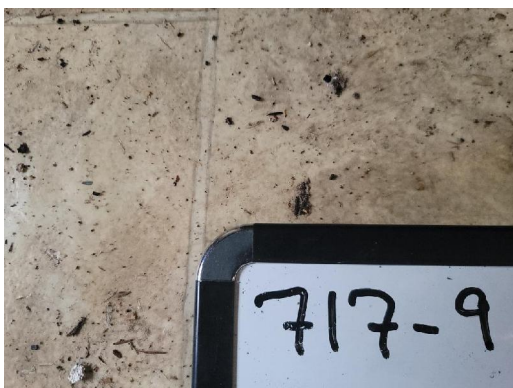
717-9
Rolled Flooring/Adhesive
Interior North Bedroom

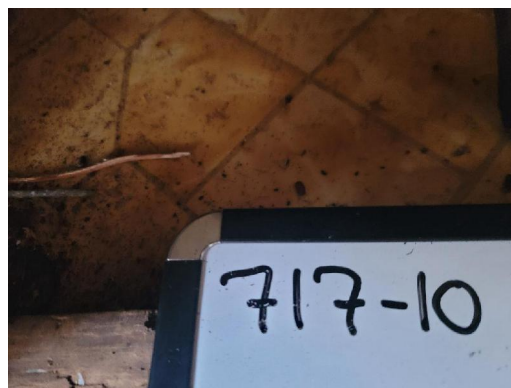
717-10
Rolled Flooring/Yellow (15% Chrysotile)
Interior North Bedroom Closet
(Appx 12 sq ft)

- Vinyl Floor Tile (VFT) (Yellow), Interior North Bedroom Closet Floor, Homogeneous Sample Area 717-10, showed 15% Chrysotile Asbestos

VFTs are NESHAP Category I non-friable ACMs. NESHAP Category I non-friable ACMs are not required to be removed prior to demolition of the building, provided that wet-demolition practices are implemented during renovations and resulting debris from the structure is properly transported to a landfill permitted for disposal of ACM. If NESHAP Category I non-friable ACMs are in poor condition and become friable during demolition, the material must be treated as a RACM and be removed by a licensed asbestos abatement contractor and disposed of at a class one landfill prior to renovation, remodeling, or demolition of the building.

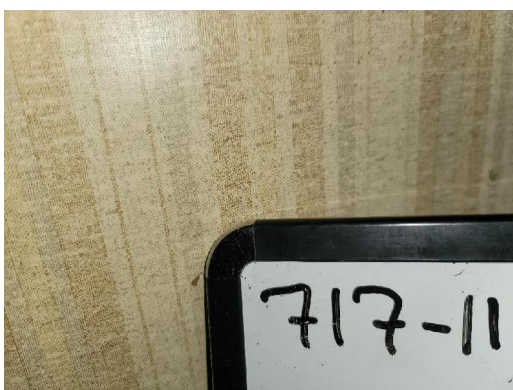
717-11
Wallpaper
Interior South Bedroom Walls

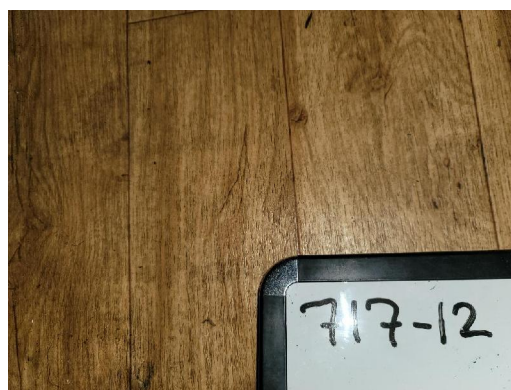
717-12
Rolled Flooring/Adhesive
Interior Water Heater Hall

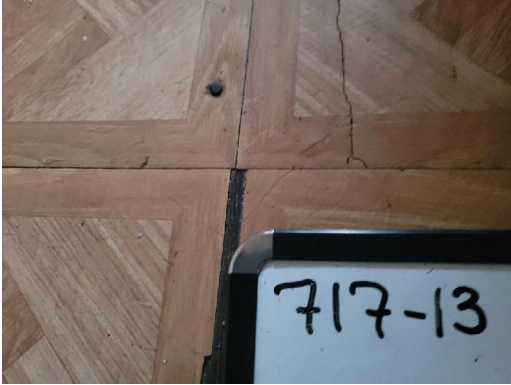
717-13
12"x12" Floor Tile/Adhesive
Interior South Bathroom

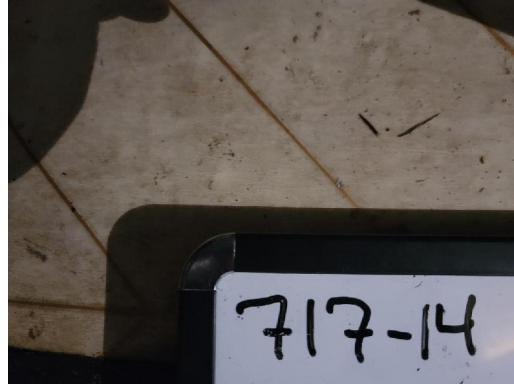
717-14
Rolled Flooring
Interior North Bathroom

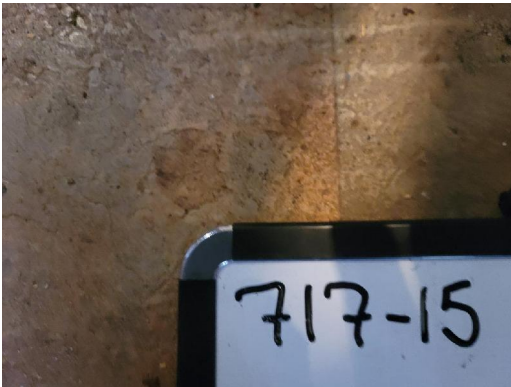
717-15
Rolled Flooring
Interior North Bathroom Hall

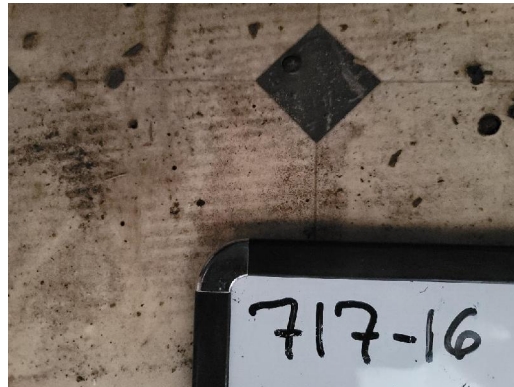
717-16
Rolled Flooring
Interior Southwest Bedroom
