ASBESTOS SURVEY REPORT

934 NE 28th Avenue
Ocala, FL 34470

January 22, 2024

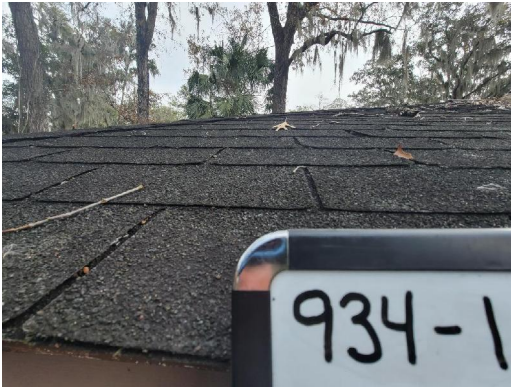
934-1
Asphalt Shingle
Typical Exterior Roof

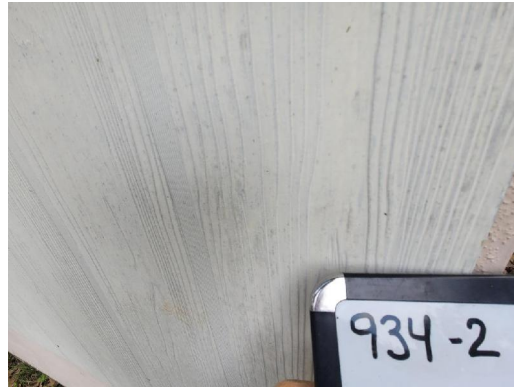
934-2
Cement Board
Exterior West Wall

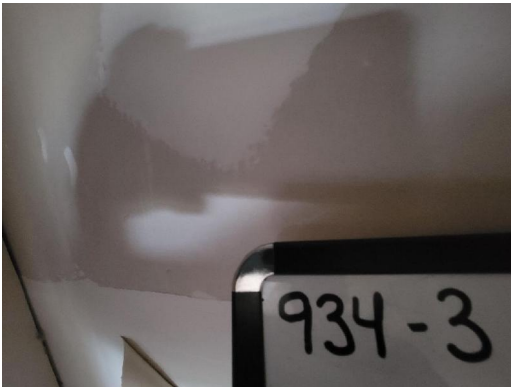
934-3
Joint Compound/Drywall
Typical Interior Walls/Ceilings

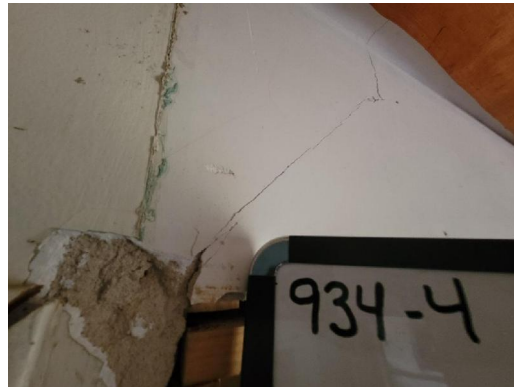
934-4
Plaster/Skim Coat/Rough Coat
Typical Interior Walls/Ceilings

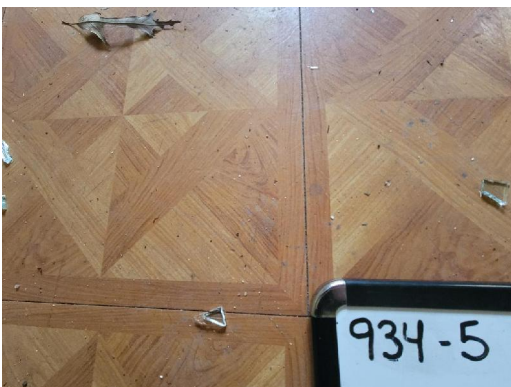
934-5
12"x12" Floor Tile/Adhesive
Interior Rear Entry

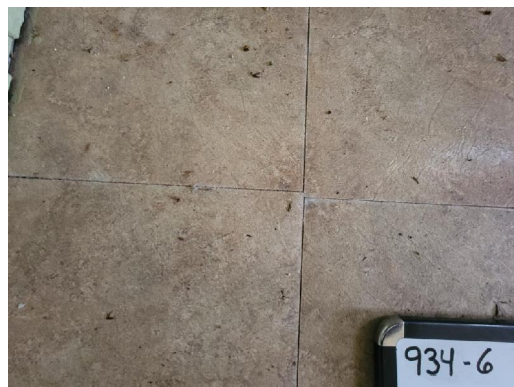
934-6
12"x12" Floor Tile/Adhesive
Interior Rear Entry

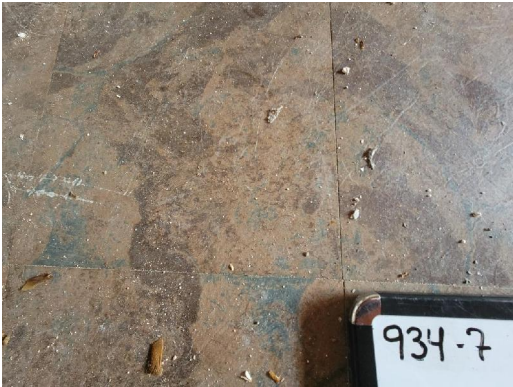
934-7
12"x12" Floor Tile/Adhesive
Interior North Bedroom
(Top Layer)

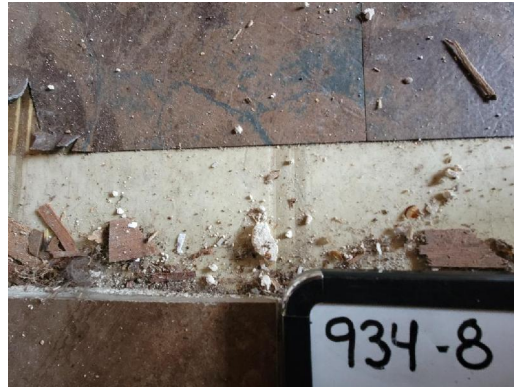
934-8
Rolled Flooring/Adhesive
Interior North Bedroom
(Bottom Layer)

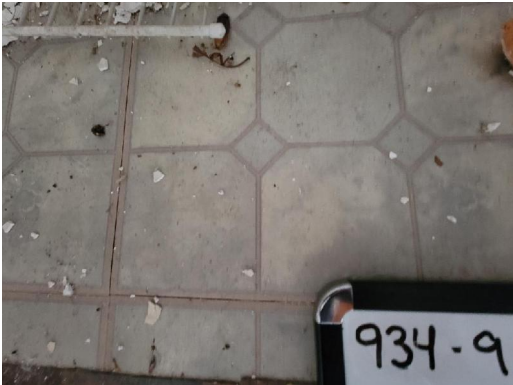
934-9
12"x12" Floor Tile/Adhesive
Interior Bathroom
(Top Layer)

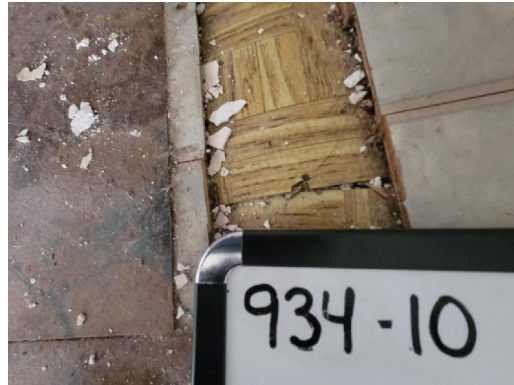
934-10
Rolled Flooring/Adhesive
Interior Bathroom
(Bottom Layer)
