ASBESTOS SURVEY REPORT

1315 SW 5th Street
Ocala, FL 34471

November 02, 2023

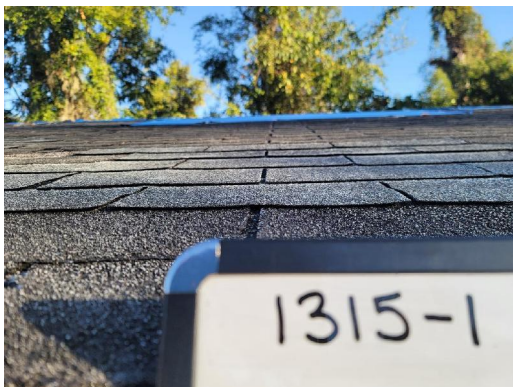
1315-1
Asphalt Shingle
Typical Exterior Roof

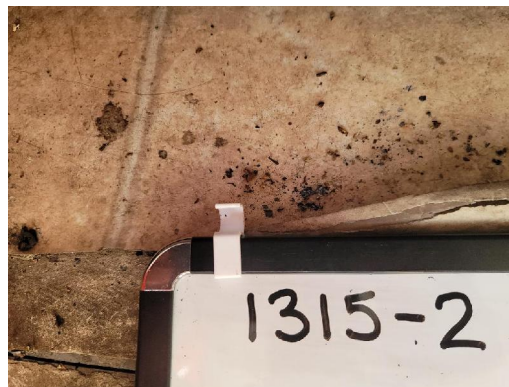
1315-2
Rolled Flooring (Top Layer)
Interior Enclosed Porch

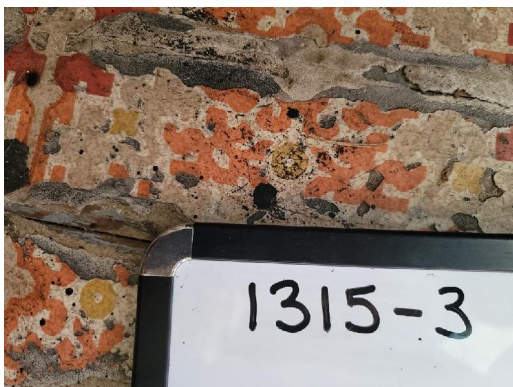
1315-3
Linoleum/Red (Bottom Layer)
(10% Chrysotile)
Interior Enclosed Porch
(Appx. 30 sf)

- Sample 1315-3-1, Linoleum Flooring (Red), Bottom Layer, Interior Enclosed Porch, showed 10% Chrysotile Asbestos

Linoleum flooring and mastic associated with linoleum flooring are National Emission Standard for Hazardous Air Pollutants (NESHAP) Category I non-friable ACMs. NESHAP Category I non-friable ACMs are not required to be removed prior to demolition of the building, provided that wet-demolition practices are implemented during renovations and resulting debris from the structure is properly transported to a landfill permitted for disposal of ACM. If NESHAP Category I non-friable ACMs are in poor condition and become friable during demolition, the material must be treated as a Regulated Asbestos Containing Material (RACM) and be removed by a licensed asbestos abatement contractor and disposed of at a class one landfill prior to renovation, remodeling, or demolition of the building.

Due to the presence of ACM, OSHA's Asbestos Standard for the Construction Industry (29 CFR 1926.1101) must be followed. Any renovation, remodeling, or demolition of RACMs must be handled by a State Licensed Contractor under Florida Administrative Code (F.A.C.) Title XXXII Chapter 469 for Asbestos Abatement. If

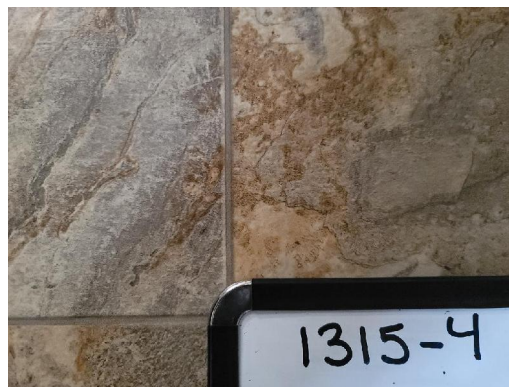
1315-4
Rolled Flooring
Interior Living Room/Kitchen/Hall
(Top Layer)

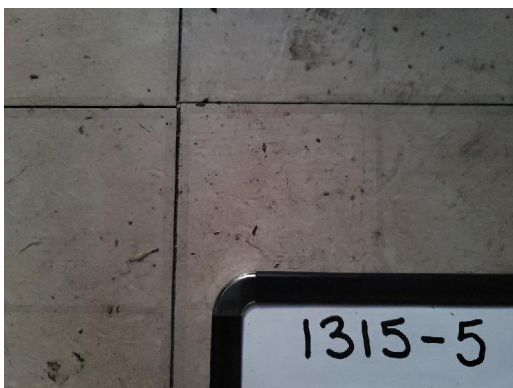
1315-5
12"x12" Floor Tile/Adhesive
Interior South Bedroom

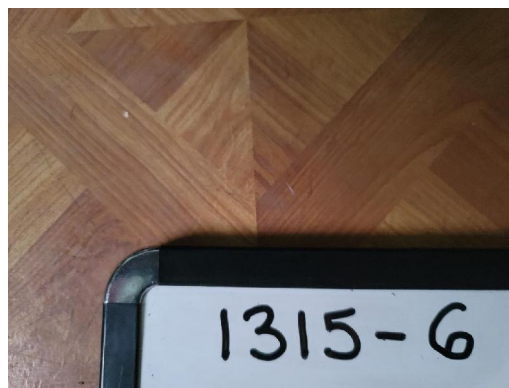
1315-6
12"x12" Floor Tile/Adhesive
Interior Southeast Bedroom

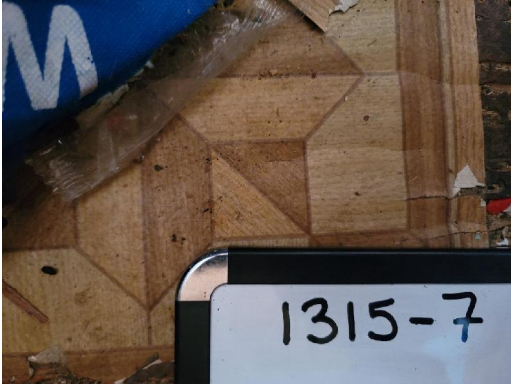
1315-7
12"x12" Floor Tile/Adhesive
Northeast Bedroom

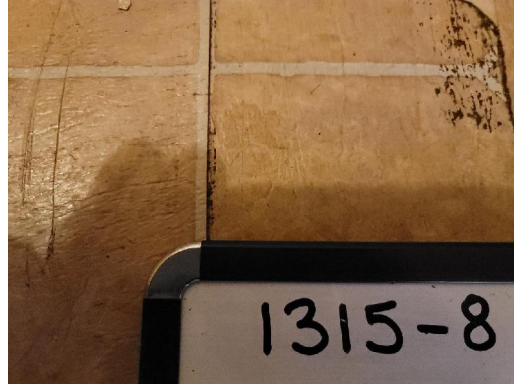
1315-8
12"x12" Floor Tile/Adhesive
Bathroom (Top Layer)
Living Room (Bottom Layer)

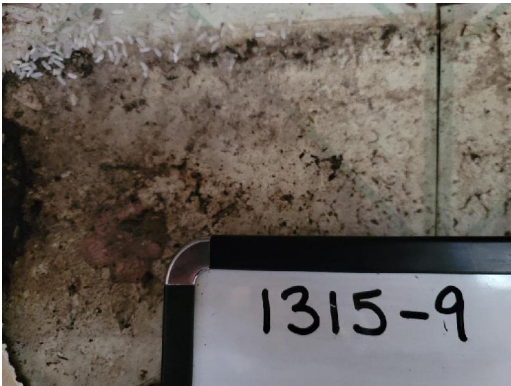
1315-9
12"x12" Floor Tile/Adhesive
Kitchen (Bottom Layer)

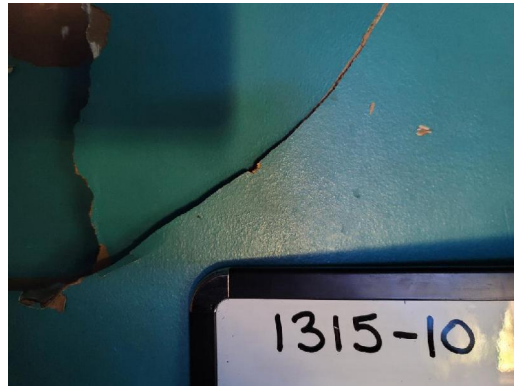
1315-10
Drywall/Joint Compound
Typical Interior Walls/Ceilings
