ASBESTOS SURVEY REPORT

923 NE 10th Avenue
Ocala, FL 34470

October 13, 2022

City of Ocala
Community Development Services
201 SE 3rd Street, 2nd Floor
Ocala, FL 34471

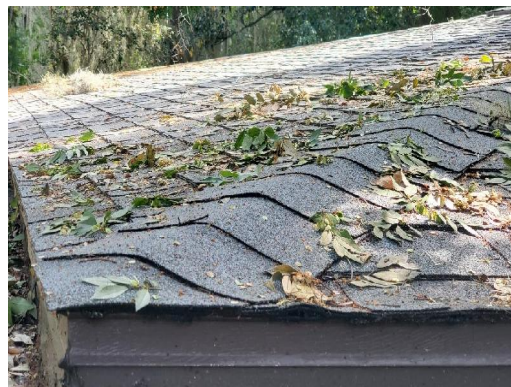
923-1
Asphalt Shingle/Tar
Typical Exterior Roof

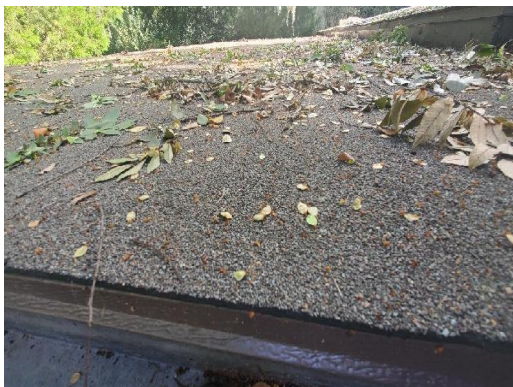
923-2
Rolled Roofing
Carport/Enclosed Porch

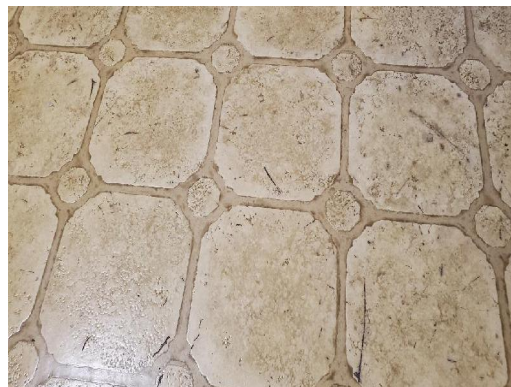
923-3
Rolled Flooring (20% Chrysotile)
Mastic
Interior Kitchen (approx. 150 sq. ft.)

- Rolled Flooring (Gray/Tan), Interior Kitchen, Homogeneous Sample Area 923-3, showed 20% Chrysotile Asbestos
- 9"x9" Vinyl Floor Tile (Tan), Interior Kitchen, Homogeneous Sample Area 923-4, showed 2% Chrysotile Asbestos
- 9"x9" Vinyl Floor Tile (Gray), Interior Floors, Homogeneous Sample Area 923-6, showed 5% Chrysotile Asbestos
- Mastic (Black) Associated with 9"x9" Vinyl Floor Tile (Gray), Interior Floors, Homogeneous Sample Area 923-6, showed 4% Chrysotile Asbestos

Vinyl floor tile, rolled flooring and mastics associated with vinyl floor tile are National Emission Standard for Hazardous Air Pollutants (NESHAP) Category I non-friable ACMs. NESHAP Category I non-friable ACMs are not required to be removed prior to demolition of the building, provided that wet-demolition practices are implemented during renovations and resulting debris from the structure is properly transported to a landfill permitted for disposal of ACM. If NESHAP Category I non-friable ACMs are in poor condition and become friable during demolition, the material must be treated as a RACM and be removed by a licensed asbestos abatement contractor and disposed of at a class one landfill prior to renovation, remodeling, or demolition of the building.

If asbestos containing materials identified within, or on, the property will be disturbed or otherwise caused to become friable within the scope of the renovation, they should be removed from the structures prior to the maneuvers taking place according to applicable regulations.

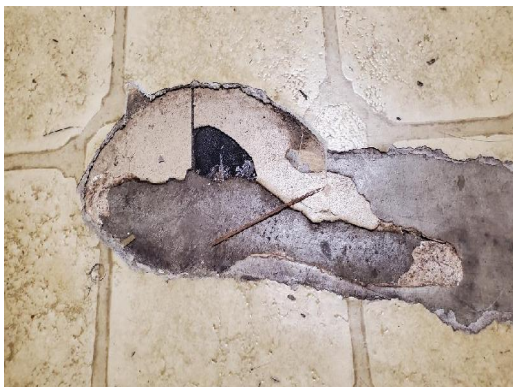
923-3-2	Mastic/Tan	Intact	No	None Detected	Interior Kitchen 150 sq. ft.	NA
923-4-1	9"x9" Floor Tile/Tan	Intact	No	2% Chrysotile	Interior Kitchen 150 sq. ft.	Category I

923-4
9"x9" Floor Tile (2% Chrysotile)
Mastic
Interior Kitchen (approx. 150 sq. ft.)

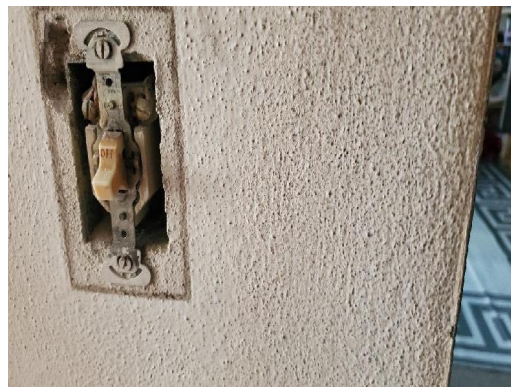
923-5
Plaster
Typical Interior Walls/Ceilings

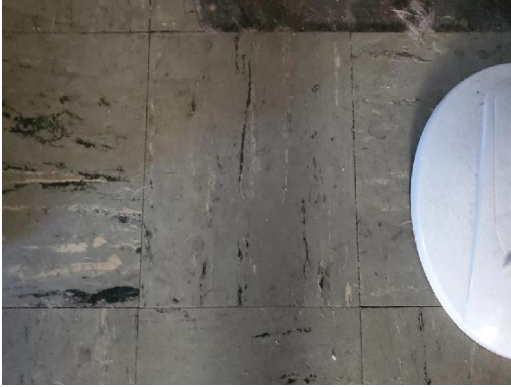
923-6

923-6-1	9"x9" Floor Tile/Gray	Intact	No	5% Chrysotile	Interior Floors 575 sq. ft.	Category I
923-6-1	Mastic/Black	Intact	No	4% Chrysotile	Interior Floors 575 sq. ft.	Category I
923-6-2	9"x9" Floor Tile/Gray	Intact	No	Not Analyzed/ Positive Stop	Interior Floors 575 sq. ft.	Category I
923-6-2	Mastic/Black	Intact	No	Not Analyzed/ Positive Stop	Interior Floors 575 sq. ft.	Category I

9"x9" Floor Tile (5% Chrysotile)

Mastic (4% Chrysotile)

Typical Interior Floors (approx. 575 sq. ft.)
