LEAD-BASED PAINT RISK ASSESSMENT REPORT

1640 NW 18th Avenue
Ocala, FL 34475

PERFORMED ON:
June 29, 2022

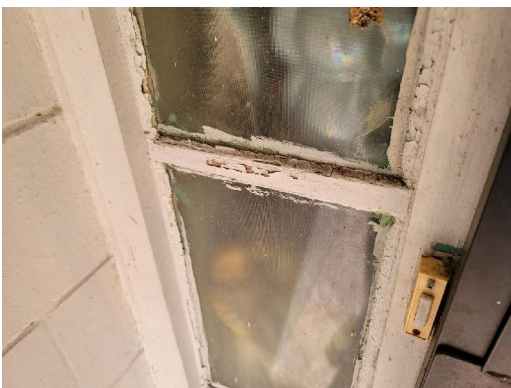
Read No.	Wall	Structure	Location	Member	Paint Cond	Substrate	Paint Color	Lead (mg/cm ²)	Mode
010 Exterior									
097	A	Door	Ctr	Casing	D	Wood	White	1.6	QM
098	A	Door	Ctr	Sidelight	D	Wood	White	1.7	QM

Exterior(010) A-Wall, Center
Wood Door Casing, Silight
Lead-Positive, Deteriorated

DKE recommends that corrective action is taken for the following components which were found to contain lead at levels greater than or equal to the regulatory level of 1.0 mg/cm² and to be in "Deteriorated" condition. All lead abatement activities should be performed by a licensed and insured Lead Abatement Contractor. It is the Lead Abatement Contractor's responsibility to follow all city, state and federal guidelines when performing lead abatement activities. It is also the Lead Abatement Contractor's responsibility to confirm all quantities and conditions:

- Option A. Paint film stabilization of lead positive components by application of 1 coat of Kilz primer or equivalent over a LSWP prepared surface and 2 top coats of exterior exposure residential paint following manufacturer's recommendations. Color chosen by owner. (IC)
- Option B. Enclosure of lead-positive components with metal coil stock using LSWP.
- Option C. Removal of lead-positive components and replacement with material similar in appearance, composition and finish using LSWP.
- Option D. Remove lead-based paint chemically and repaint using LSWP.
