Exhibit D - LEAD RISK ASSESSMENT REPORT

LEAD-BASED PAINT RISK ASSESSMENT REPORT

2347 NE 16th Court
Ocala, FL 34470

PERFORMED ON:
October 25, 2021

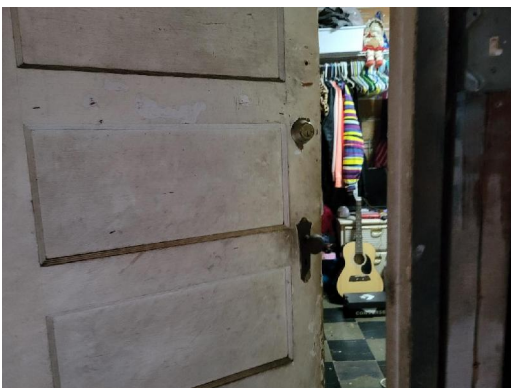
Garage(001) D-Wall, Center
Wood Door and Jamb
Lead-Positive, Deteriorated

- Option A. Friction control and paint film stabilization of lead-positive door components by application of 1 coat of Kilz primer or equivalent over a LSWP prepared surface and 2 top coats of exterior exposure residential paint following manufacturer's recommendations. Color chosen by owner. (IC)
- Option B. Remove lead-positive components and install a new steel insulated door including new jambs, casing, and threshold using LSWP.
- Option C. Remove lead-based paint chemically and repaint using LSWP.

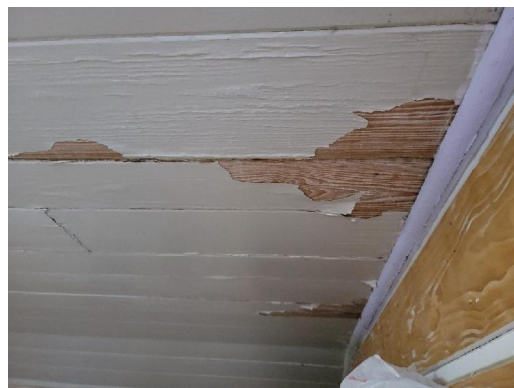
Bedroom A(002) D-Wall, Center
Wood Ceiling
Lead-Positive, Deteriorated

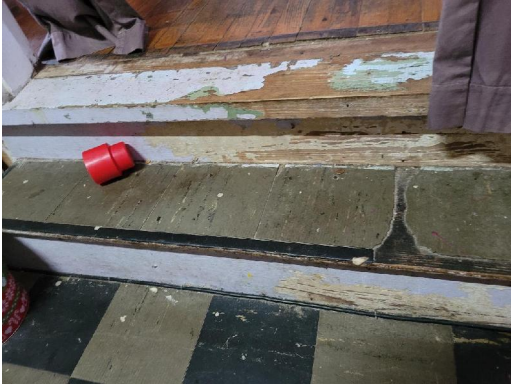
Bedroom A(002) D-Wall, Right
Wood Stair Tread and Riser
Lead-Positive, Deteriorated

- Option A. Paint film stabilization of all lead positive components by application of 1 coat of Kilz primer or equivalent over a LSWP prepared surface and 2 top coats of interior exposure residential paint following manufacturer's recommendations. Color chosen by owner. Install rubber treads or carpet runner to minimize friction and impact surfaces. (IC)
- Option B. Removal of lead-positive components and replacement with material similar in appearance, composition, and finish using LSWP.
- Option C. Remove lead-based paint from all stair components chemically and repaint using LSWP.

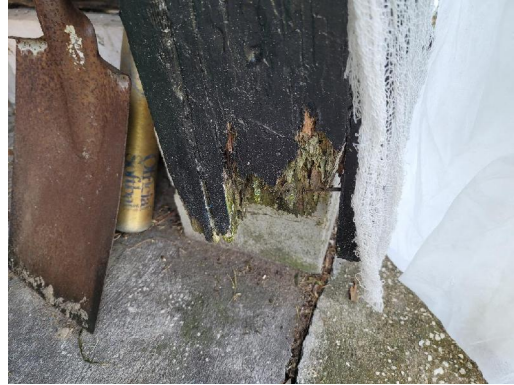
Exterior(009) A-Wall, Left
Wood Garage Door Jamb
Lead-Positive, Deteriorated

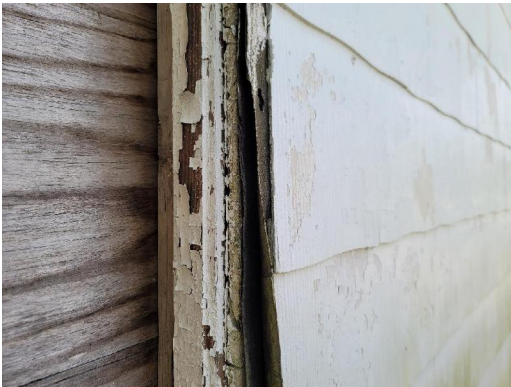
Exterior(009) B-Wall, Left
Wood Door Jamb
Lead-Positive, Deteriorated

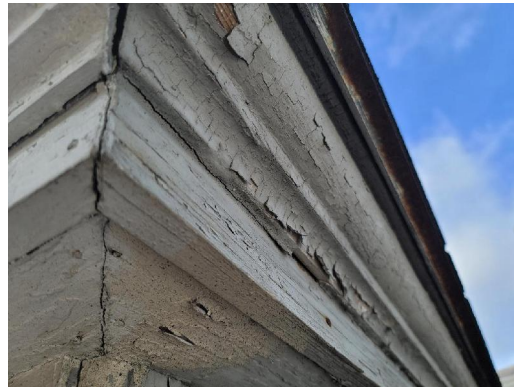
Exterior(009) C-Wall, Center
Wood Soffit and Fascia
Lead-Positive, Deteriorated

- Option A. Removal of lead-positive components and replacement with material similar in appearance, composition and finish using LSWP.
- Option B. Enclosure of all lead-positive components with metal coil stock using LSWP.
- Option C. Remove lead-based paint chemically and repaint using LSWP.

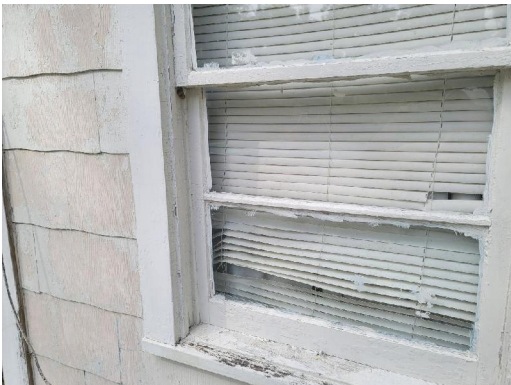
Exterior(009) C-Wall, Left
Wood Window Components
Lead-Positive, Deteriorated

- Option A. Friction control and paint film stabilization of lead-positive window components by application of 1 coat of Kilz primer or equivalent over a LSWP prepared surface and 2 top coats of exterior exposure residential paint following manufacturer's recommendations. Color chosen by owner. (IC)
- Option B. Removal and replacement of lead-positive window components using LSWP.
- Option C. Remove lead-based paint from all window components chemically and repaint using LSWP.

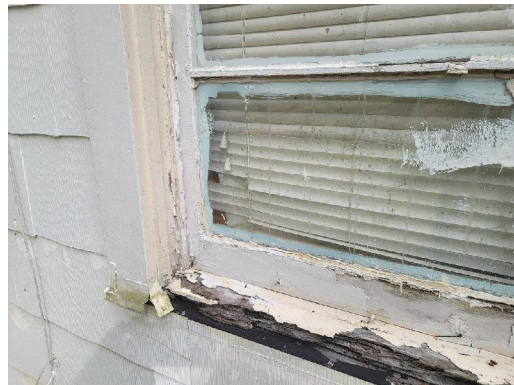
Exterior(009) D-Wall, Right
Wood Window Components
Lead-Positive, Deteriorated
