## LEAD-BASED PAINT INSPECTION REPORT

1218 NE 46th Court  
Ocala, FL 34470

PERFORMED ON:  
November 29, 2023

## ASBESTOS SURVEY REPORT

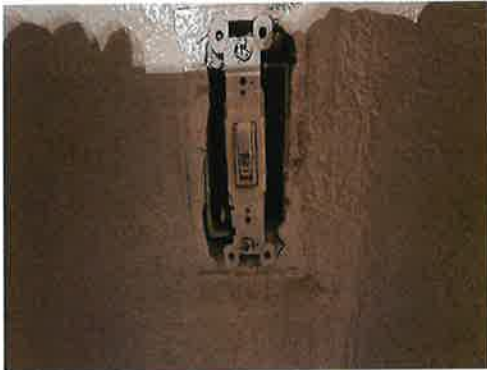
1218-1  
Plaster  
Typical Interior Walls/Ceilings

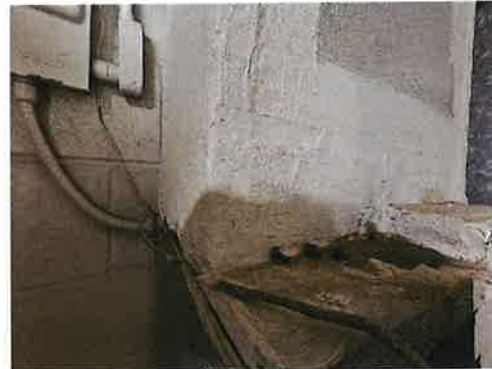
1218-2  
Duct Mastic  
Typical Interior HVAC

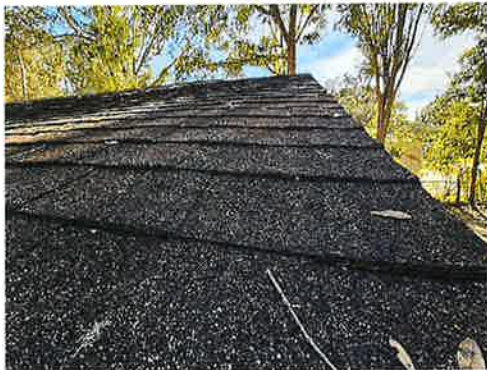
1218-3  
Asphalt Shingle/Tar  
Typical Exterior Roof
