## LEAD-BASED PAINT INSPECTION REPORT

1218 NE 46th Court  
Ocala, FL 34470

**PERFORMED ON:**  
November 29, 2023

## ASBESTOS SURVEY REPORT

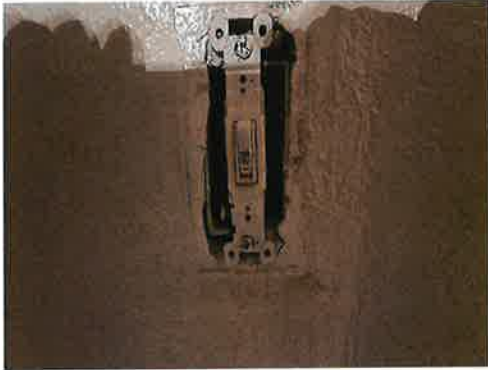
1218-1  
Plaster  
Typical Interior Walls/Ceilings

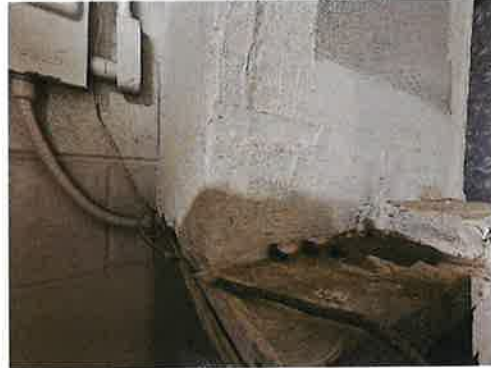
1218-2  
Duct Mastic  
Typical Interior HVAC

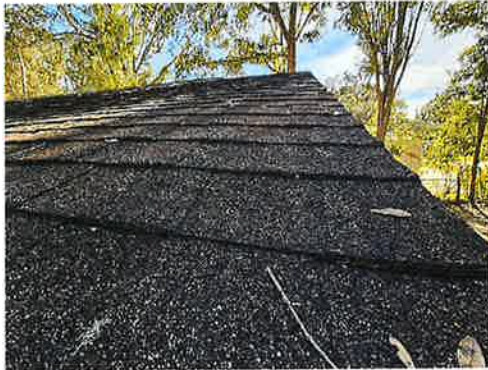
<i>Sample Number</i>	<i>Description</i>	<i>Condition</i>	<i>Friable</i>	<i>Asbestos Percent and Type</i>	<i>Location/ Amount</i>	<i>NESHAP Category</i>
1218-3-2	Asphalt Shingle/Black	Intact	No	None Detected	Typical Exterior Roof	NA
1218-3-2	Tar/Black	Intact	No	None Detected	Typical Exterior Roof	NA

1218-3  
Asphalt Shingle/Tar  
Typical Exterior Roof
