LEAD-BASED PAINT INSPECTION REPORT

1218 NE 46th Court
Ocala, FL 34470

PERFORMED ON:
November 29, 2023

ASBESTOS SURVEY REPORT

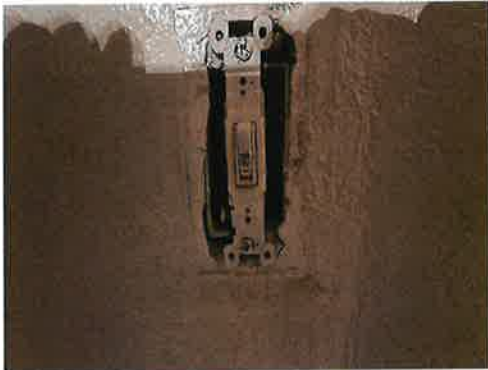
1218-1
Plaster
Typical Interior Walls/Ceilings

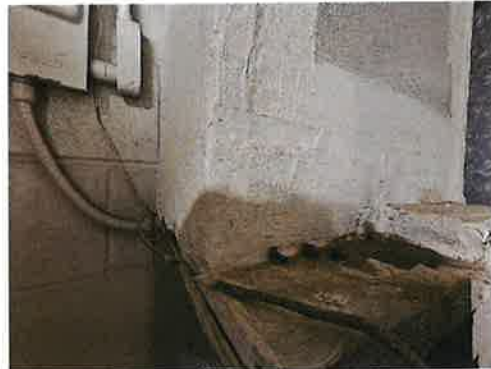
1218-2
Duct Mastic
Typical Interior HVAC

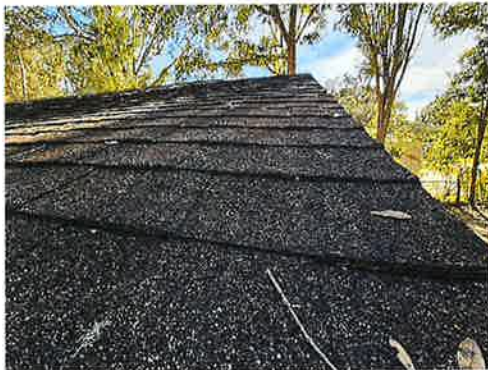
Sample Number	Description	Condition	Friable	Asbestos Percent and Type	Location/ Amount	NESHAP Category
1218-3-2	Asphalt Shingle/Black	Intact	No	None Detected	Typical Exterior Roof	NA
1218-3-2	Tar/Black	Intact	No	None Detected	Typical Exterior Roof	NA

1218-3
Asphalt Shingle/Tar
Typical Exterior Roof
