## LEAD-BASED PAINT RISK ASSESSMENT REPORT

2190 NW 8th Street  
Ocala, FL 34475

July 22, 2023

Re: Lead-Based Paint Inspection/Risk Assessment Report

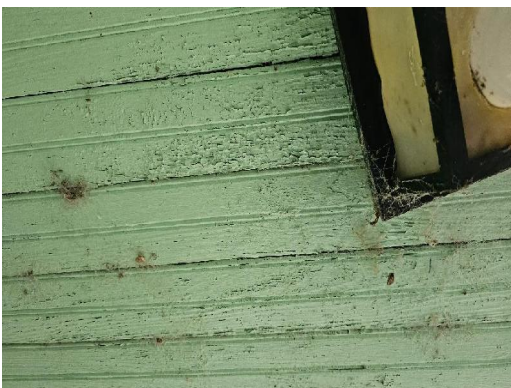
Read No.	Wall	Structure	Location	Member	Paint Cond	Substrate	Paint Color	Lead (mg/cm <sup>2</sup> )	Mode
008 Exterior									
067	B	Porch Ceilin	Rgt		D	Wood	green	5.2	QM

Exterior(008) B-Wall, Right  
Wood Porch Ceiling  
Lead-Positive, Deteriorated

- Option A. Paint film stabilization of all lead positive components by application of 1 coat of Kilz primer or equivalent over a LSWP prepared surface and 2 top coats of exterior exposure residential paint following manufacturer's recommendations. Color chosen by owner. (IC)
- Option B. Enclosure of all lead-positive components with vinyl soffit/metal coil stock using LSWP.
- Option C. Encapsulation of lead-positive components by application of LBC (Lead Barrier Compound) over a LSWP prepared surface.
- Option D. Removal of lead-positive components and replacement with material similar in appearance, composition and finish using LSWP.
- Option E. Remove lead-based paint chemically and repaint using LSWP.

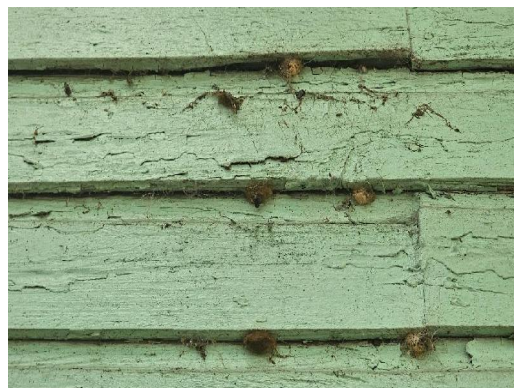
Exterior(008) B-Wall, Right  
Wood Wall  
Lead-Positive, Deteriorated

- Option A. Paint film stabilization of siding by application of 1 coat of Kilz primer or equivalent over a LSWP prepared surface and 2 top coats of exterior exposure residential paint following manufacturer's recommendations. Color chosen by owner. (IC)
- Option B. Enclosure of walls with house wrap and vinyl siding using LSWP.
- Option C. Remove lead-based paint chemically and repaint using LSWP.

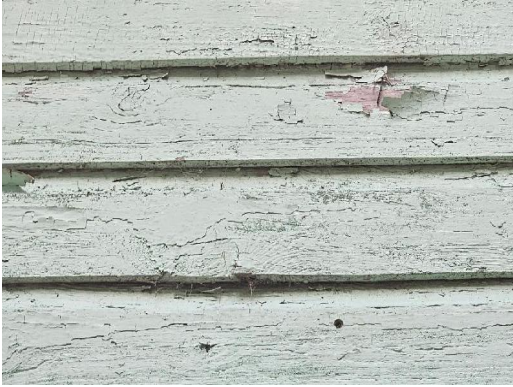
Exterior(008) D-Wall, Center  
Wood Wall  
Lead-Positive, Deteriorated
