## LEAD-BASED PAINT RISK ASSESSMENT REPORT

948 NE 6th Street  
Ocala, FL 34470

**PERFORMED ON:**  
November 29, 2023

Re: Lead-Based Paint Inspection/Risk Assessment Report  
Property Address: **948 NE 6th Street, Ocala, FL 34470**  
Property Owner: **Marietta Stein**  
Phone: **352-355-0828**

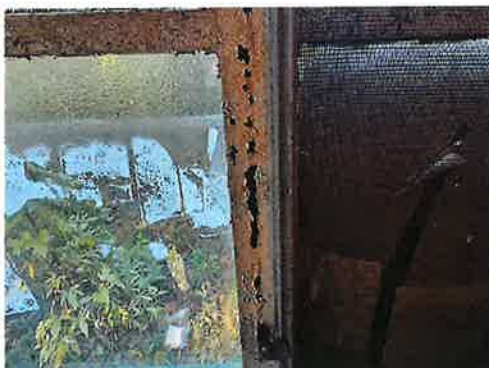
**Bedroom B(013) D-Wall, Left  
Metal Window Sash  
Lead-Positive, Deteriorated**

- Option A. Paint film stabilization of lead-positive components by application of Kilz primer or equivalent over a LSWP prepared surface and 2 top coats of an interior exposure paint following manufacturer's recommendations. Impact/friction control measures should be taken as necessary. (IC)
- Option B. Removal of positive components and replacement with material similar in appearance, composition, and finish using LSWP.
- Option C. Remove lead-based paint from all window components chemically and repaint using LSWP.

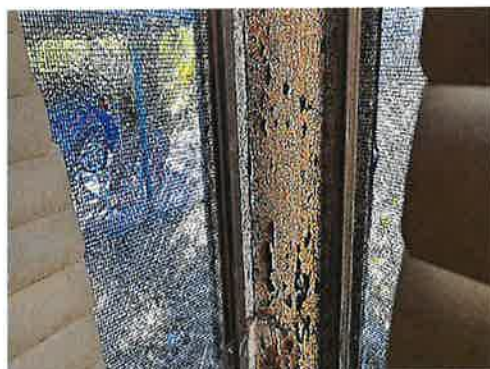
**Bedroom C(014) B-Wall, Right  
Metal Window Casing  
Lead-Positive, Deteriorated**

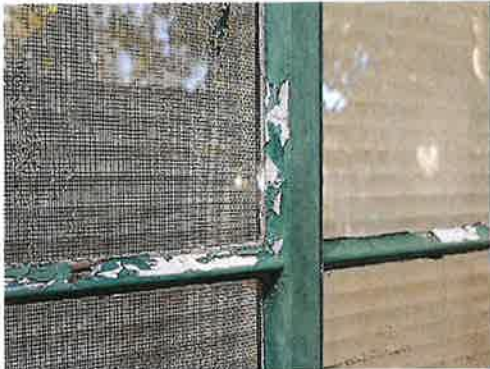
Exterior(015) A-Wall, Right  
Metal Window Sash  
Lead-Positive, Deteriorated

- Option A. Paint film stabilization of lead-positive components by application of 1 coat of Kilz primer or equivalent over a LSWP prepared surface and 2 top coats of exterior exposure residential paint following manufacturer's recommendations. Impact/friction control measures should be taken as necessary. (IC)

- Option B. Removal and replacement of window and wrapping with metal exterior window components using LSWP.
- Option C. Remove lead-based paint from all window components chemically and repaint using LSWP.

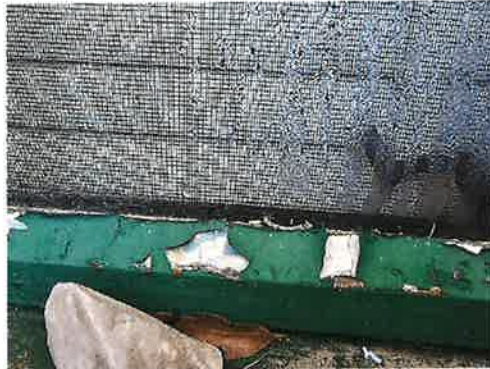
Exterior(015) C-Wall, Center  
Metal Window Casing  
Lead-Positive, Deteriorated

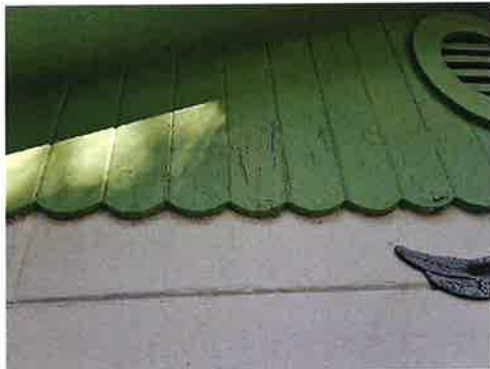
Exterior(015) C-Wall, Right  
Upper Wood Wall  
Lead-Positive, Deteriorated

- Option A. Paint film stabilization of siding by application of 1 coat of Kilz primer or equivalent over a LSWP prepared surface and 2 top coats of exterior exposure residential paint following manufacturer's recommendations. Color chosen by owner. (IC)
- Option B. Enclosure of walls with house wrap and vinyl siding using LSWP.
- Option C. Remove lead-based paint chemically and repaint using LSWP.

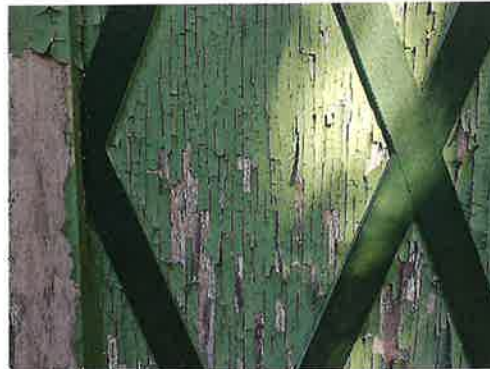
Exterior(015) C-Wall, Right  
Wood Garage Door  
Lead-Positive, Deteriorated

- Option A. Paint film stabilization of lead-positive components by application of 1 coat of Kilz primer or equivalent over a LSWP prepared surface and 2 top coats of exterior exposure residential paint following manufacturer's recommendations. Impact/friction control measures should be taken as necessary. (IC)
- Option B. Removal and replacement of garage door using LSWP.
- Option C. Remove lead-based paint from garage door chemically and repaint using LSWP.

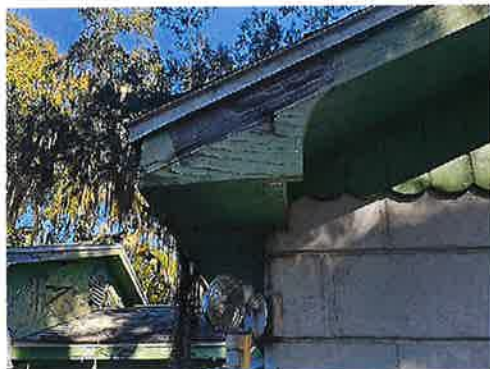
Exterior(015) C-Wall, Center  
Wood Fascia  
Lead-Positive, Deteriorated

- Option A. Paint film stabilization by application of 1 coat of Kilz primer or equivalent over a LSWP prepared surface and 2 top coats of exterior exposure residential paint following manufacturer's recommendations. Color chosen by owner. (IC)
- Option B. Enclosure of all lead-positive components with vinyl soffit/metal coil stock using LSWP.
- Option C. Encapsulation of lead-positive components by application of LBC (Lead Barrier Compound) using LSWP.
- Option D. Removal of lead-positive components and replacement with material similar in appearance, composition, and finish using LSWP.
- Option E. Remove lead-based paint chemically and repaint using LSWP.

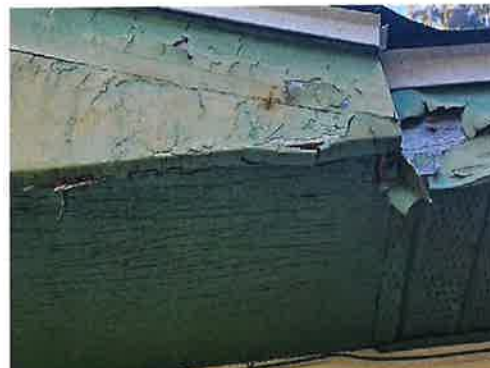
Exterior(015) D-Wall, Left  
Wood Fascia  
Lead-Positive, Deteriorated

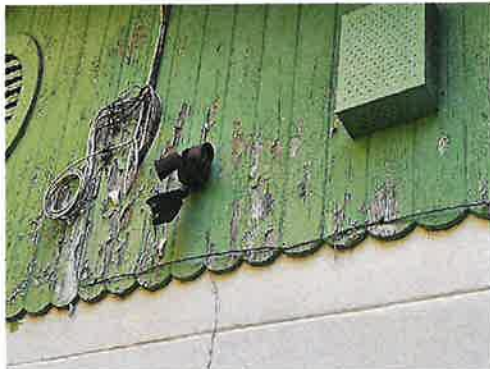
Exterior(015) D-Wall, Left  
Upper Wood Wall  
Lead-Positive, Deteriorated

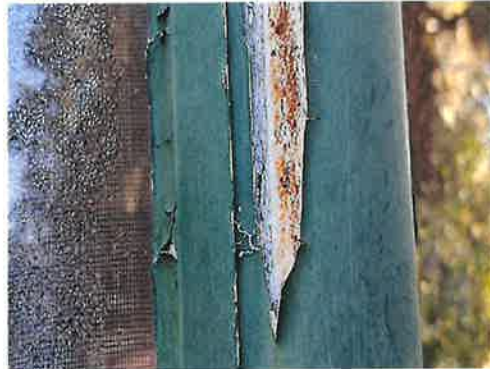
Exterior(015) D-Wall, Right  
Metal Window Sash, Casing  
Lead-Positive, Deteriorated
