MOLD INSPECTION REPORT

Marietta Stein
948 NE 6th Street
Ocala, FL 34470

November 29, 2023

Brenden Lavelly
Licensed Florida Mold Assessor
MRSA4603

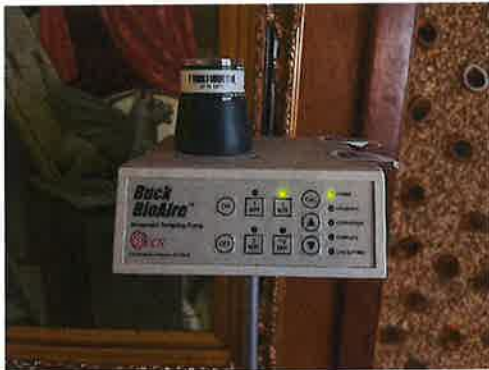
| Airborne Mold Spores by Spore Trap Technique and/or Surface Sampling by Tape/Swab | | | |
|--|--|---|---|
| Air-O-Cell Spore Trap 37161875 | Interior Family Room Preliminary Sample Collected at Breathing Level | Aspergillus/Penicillium | 148000 |

Interior Family Room sample

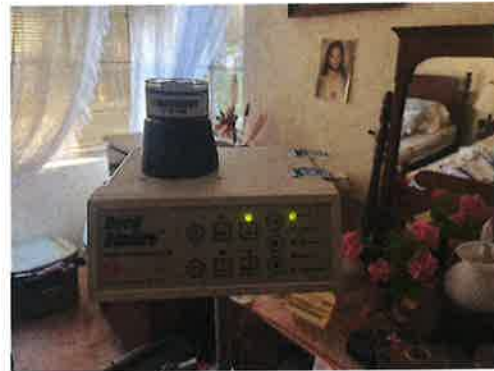
| Airborne Mold Spores by Spore Trap Technique and/or Surface Sampling by Tape/Swab | | | |
|--|--|---|---|
| Air-O-Cell Spore Trap 37161889 | Interior Southwest Bedroom Preliminary Sample Collected at Breathing Level | Aspergillus/Penicillium | 112000 |

Interior Southwest Bedroom sample

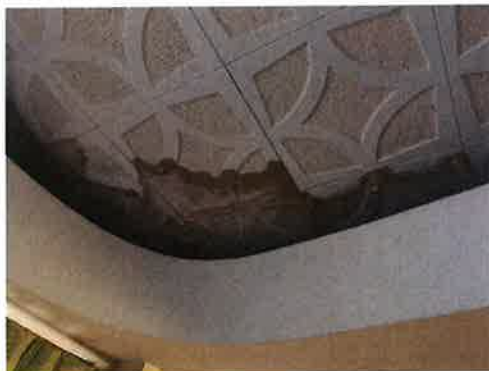
Interior Family Room
East tile ceiling
Visible water damage
Visible microbial growth

- Clean/treat all affected finished wood walls, flooring, and trim. Remove all finished wood walls, flooring, and trim that cannot be adequately cleaned/treated.
- Remove all affected tile ceiling.
- Remove all affected plaster ceiling.
- Properly bag and dispose of all contaminated waste materials.
- Treat and encapsulate all newly-exposed framing components with two coats of an EPA-registered mold resistant coating to prevent mold growth, if applicable.
- Treat and encapsulate any newly-exposed sub-flooring with two coats of an EPA-registered mold resistant coating to prevent mold growth, if applicable.

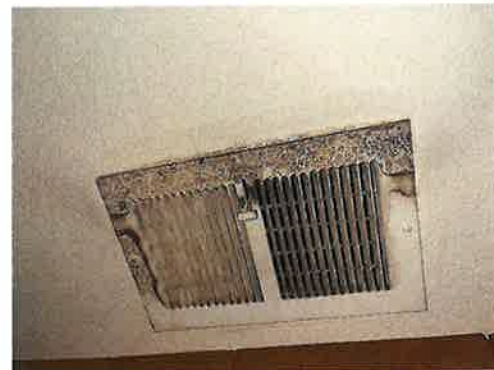
| Airborne Mold Spores by Spore Trap Technique and/or Surface Sampling by Tape/Swab | | | |
|--|--|---|---|
| Bio-Tape 948-1 | Interior Family Room Preliminary Sample Collected from metal HVAC vent | Cladosporium | High |

Interior Family Room
East plaster ceiling, metal HVAC vent
Visible water damage
Visible microbial growth

•Inspection and cleaning of the HVAC system, including air handler, ductwork, vents, filters, exhaust systems, etc., by a licensed and insured HVAC contractor is recommended.

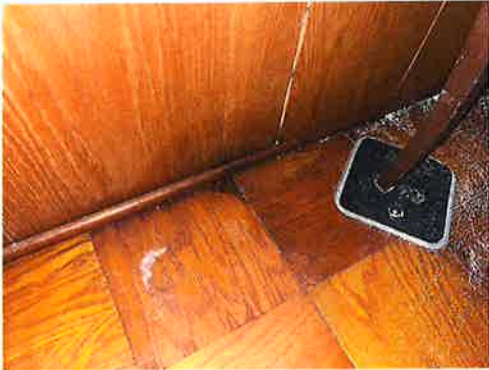
Interior Family Room
East wood wall, flooring, and trim
Visible water damage
Visible microbial growth

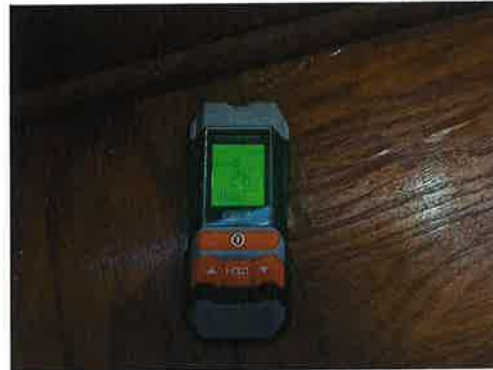
| Interior Room Name | Drying Standard | Location | Moisture Content (%) |
|---|---|---|---|
| Family Room | >15% | East wood flooring | 26 |

Note: It is generally accepted that wood rots when it contains 15% or greater moisture content (MC). Therefore, a reading at or above 15% MC in any organic building material indicates a hazardous condition which should be investigated further. Generally, moisture content below 15% inhibits growth of both destructive fungi and surface fungi.

Interior Family Room
East wood flooring
Elevated moisture content (26%)

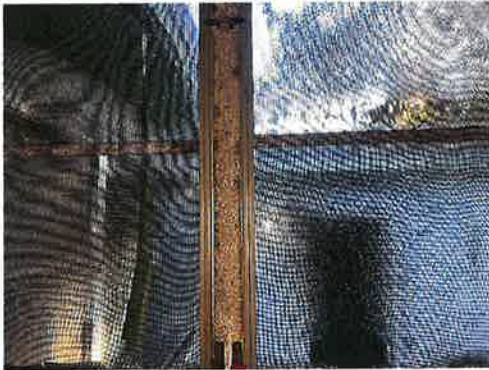
Interior Dining Room
South window casing
Visible microbial growth

•Inspection/repair/sealing/replacement of all window systems by a licensed and insured contractor is recommended.
