Exhibit C - ASBESTOS SURVEY REPORT

ASBESTOS SURVEY REPORT

2347 NE 16th Court
Ocala, FL 34470

October 25, 2021

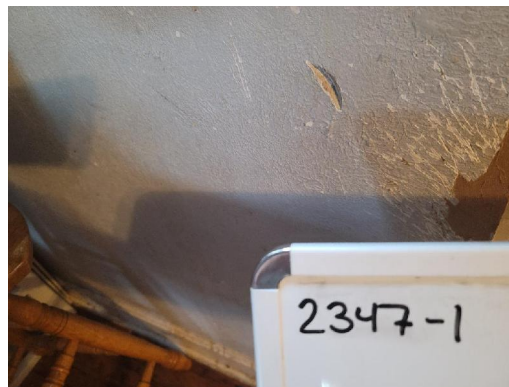
| Bulk Collection and Sample Analysis Results | | | | | | |
|--|---|---|---|---|---|---|
| 2347-1-1 | Drywall (White) | Intact | Yes | None Detected | Typical Interior Walls/Ceilings | NA |
| 2347-1-1 | Joint Compound (Cream) | Intact | Yes | None Detected | Typical Interior Walls/Ceilings | NA |

2347-1
Drywall, Joint Compound
Typical Interior Walls

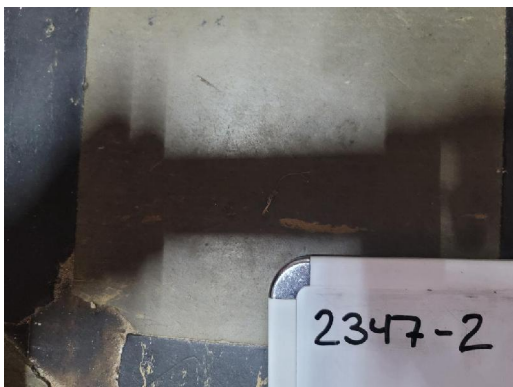
| Bulk Collection and Sample Analysis Results | | | | | | |
|--|---|---|---|---|---|---|
| 2347-2-1 | 9"x9" Floor Tile (Tan) | Damaged | No | 6% Chrysotile | Bedroom A (48' sq.) | Category I |
| 2347-2-1 | Mastic (Brown) | Damaged | No | 4% Chrysotile | Bedroom A (48' sq.) | Category I |

2347-2
9" x 9" Floor Tile – Tan (6% Chrysotile)
Mastic (4% Chrysotile)
Bedroom A (48 square feet)

If asbestos containing materials identified within, or on, the property will be disturbed or otherwise caused to become friable within the scope of the renovation, they should be removed from the structures prior to the maneuvers taking place according to applicable regulations.

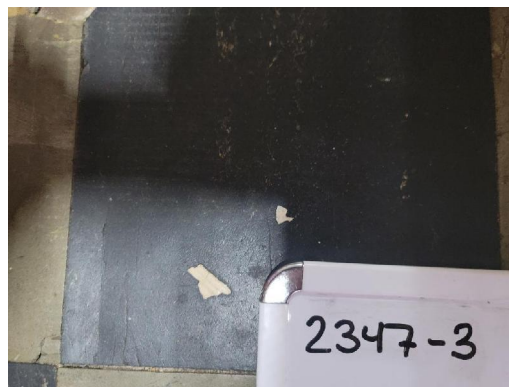
| Bulk Collection and Sample Analysis Results | | | | | | |
|--|---|---|---|---|---|---|
| 2347-3-1 | 9"x9" Floor Tile (Black) | Damaged | No | 3% Chrysotile | Bedroom A (48' sq.) | Category I |
| 2347-3-1 | Mastic (Brown) | Damaged | No | 3% Chrysotile | Bedroom A (48' sq.) | Category I |

2347-3
9" x 9" Floor Tile – Black (3% Chrysotile)
Mastic (3% Chrysotile)
Bedroom A (48 square feet)

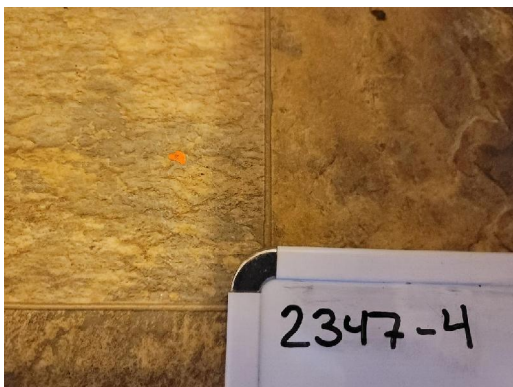
| Bulk Collection and Sample Analysis Results | | | | | | |
|--|---|---|---|---|---|---|
| 2347-4-1 | Rolled Flooring (Tan) | Damaged | No | None Detected | Kitchen | NA |
| 2347-4-1 | Mastic (Brown) | Damaged | No | None Detected | Kitchen | NA |

2347-4
Rolled Flooring
Mastic
Kitchen (78 square feet)

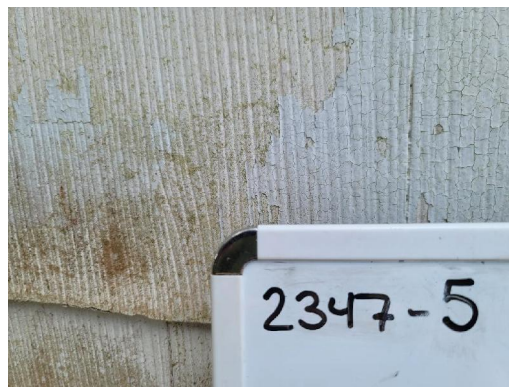
| Bulk Collection and Sample Analysis Results | | | | | | |
|--|---|---|---|---|---|---|
| 2347-5-1 | Transite Siding (White) | Damaged | No | 10% Chrysotile | Typical Exterior Walls | Category II |

2347-5
Transite Siding (10% Chrysotile)
Typical Exterior Walls

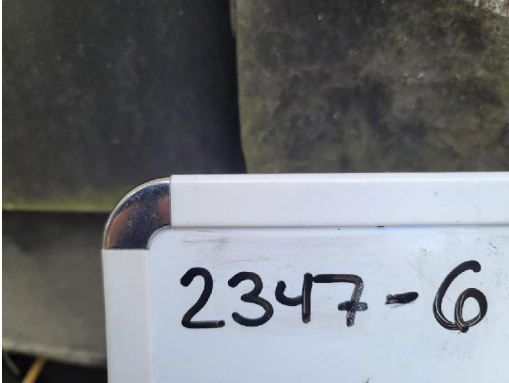
| Bulk Collection and Sample Analysis Results | | | | | | |
|--|---|---|---|---|---|---|
| 2347-6-1 | House Wrap (Felt) | Damaged | No | None Detected | Typical Exterior Walls | NA |

2347-6
House Wrap
Typical Exterior Walls

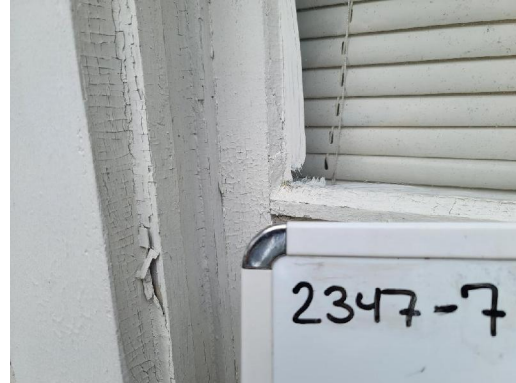
| Bulk Collection and Sample Analysis Results | | | | | | |
|--|---|---|---|---|---|---|
| 2347-7-1 | Window Glazing (White) | Damaged | Yes | <1% Chrysotile | 5 Exterior Windows | NA |

2347-7
Window Glazing (<1% Chrysotile)
5 Exterior Windows

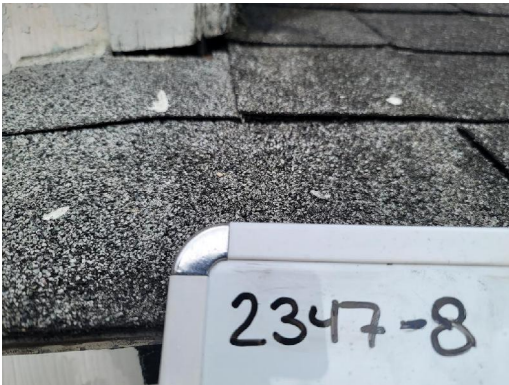
| Bulk Collection and Sample Analysis Results | | | | | | |
|--|---|---|---|---|---|---|
| 2347-8-1 | Asphalt Shingle | Intact | No | None Detected | Typical Exterior Roof | NA |

2347-8
Asphalt Shingle
Typical Exterior Roof
