ASBESTOS SURVEY REPORT

3159 SE 3rd Street
Ocala, FL 34471

August 25, 2022

City of Ocala
Community Development Services
201 SE 3rd Street, 2nd Floor
Ocala, FL 34471

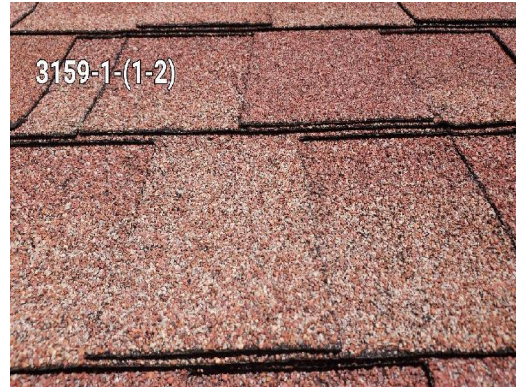
3159-1
Asphalt Shingle/Red, Tar/Black
Typical Exterior Roof

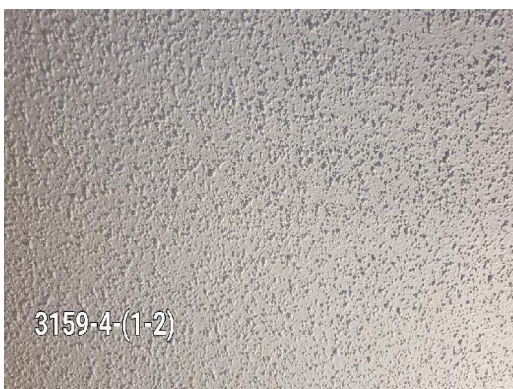
3159-4
Ceiling Surfacing Texture/Cream
(2% Chrysotile)
Typical Interior Ceilings

- Ceiling Surfacing Texture Material (Cream), Typical Interior Ceilings, Homogeneous Sample Area 3159-4-1, showed 2% Chrysotile Asbestos

Textured ceiling material is a RACM. RACMs must be removed by a licensed asbestos abatement contractor following OSHA Class I work activities and disposed of at a class one landfill prior to renovation, remodeling or demolition of the building.
